INVESTIGATING DAMAGE EVENTS RELATED TO THE TRANSPORT OF DANGEROUS GASES

ENGLER Ádám

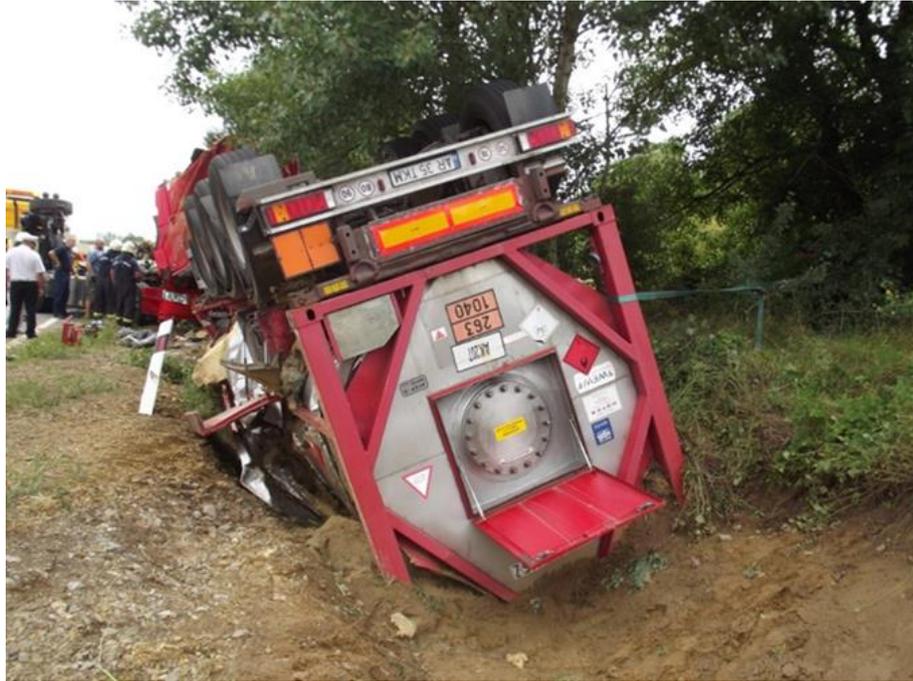
On the 27th of July 2017. short after midday a call run into the emergency centre, according to that in between Komoró and Tiszabezdéd a tank car carrying UN 1040 etilen-oxid nitrogene called dangerous good, prostrated into a pit/ trench and the driver stuck in the lorry/ tank car driver's cabin. The fireman and disaster recovery unit arrived to the scene identifying the load of the truck by using safety equipment and gasmasks/scuba. The ambulance stated that the driver who was stuck in the driver's cabin is already dead. The police closed all the three road leading to the scene of the accident and the disaster recovery made a 300 metres safety zone plus they closed the area. The Romanian owner of the truck and the Austrian owner of the tank's Hungarian agent arrived on the scene, because of the carried dangerous good downloading a special equipment was needed a German technician group arrived to the scene as well. Using a gas sensor they have made a lot of measurements by proving that the disaster recovery measurement were right and the tank is not leaking.

2. figure Picture of the accident [8]

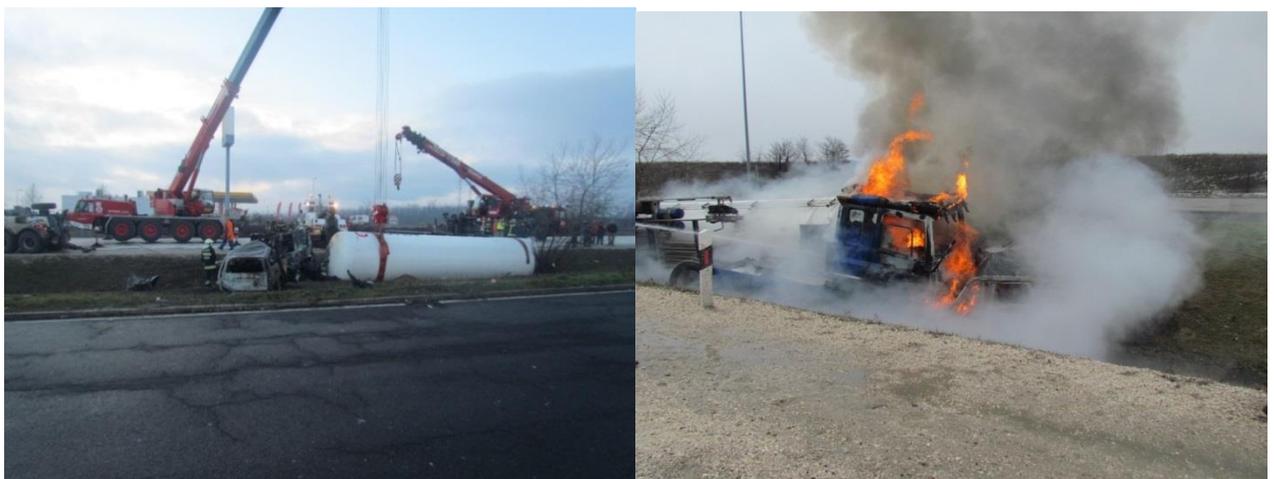
On the 10th of January 2016 on the M2 high-way tank car transporting deep-frozen liquid nitrogen run into /crashed into a personal car and as a result of that both vehicle fired. The fire partment of the disaster recovery authority turn off the flames of the fire and until the technician rescue they diverted the traffic by closing two lanes. The driver of the truck got carried away by the ambulance whilst the other driver died in the accident.

3. figure Pictures of the accident [8]

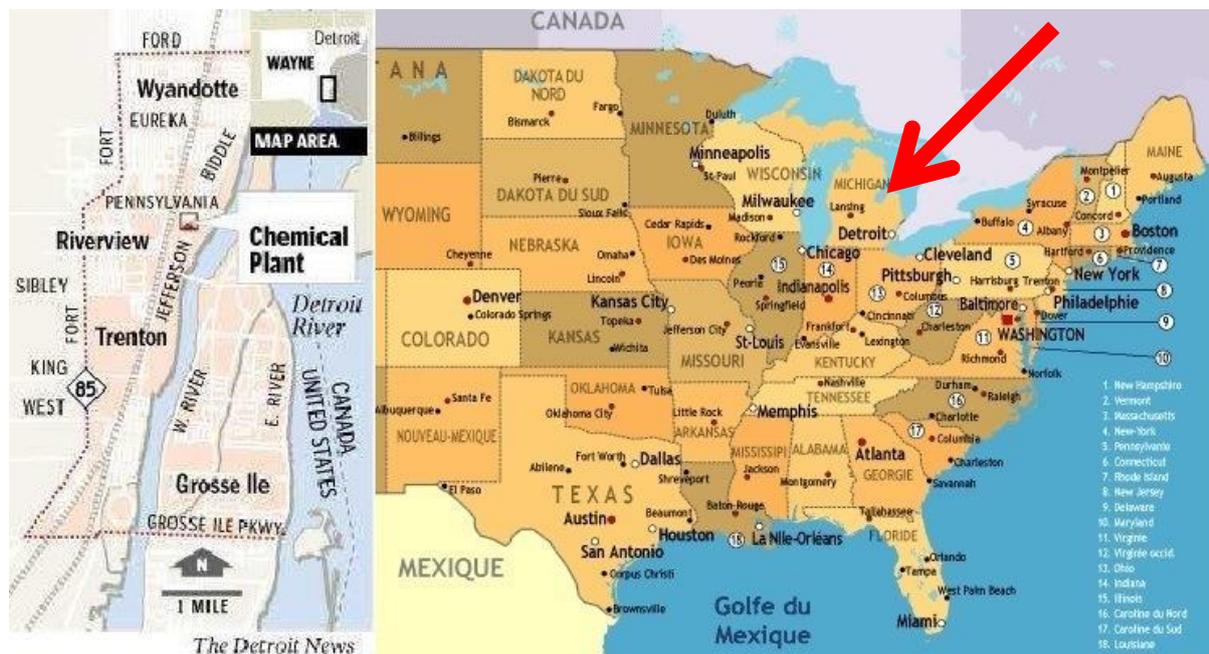
4. figure State of Michigan, accident site [11]

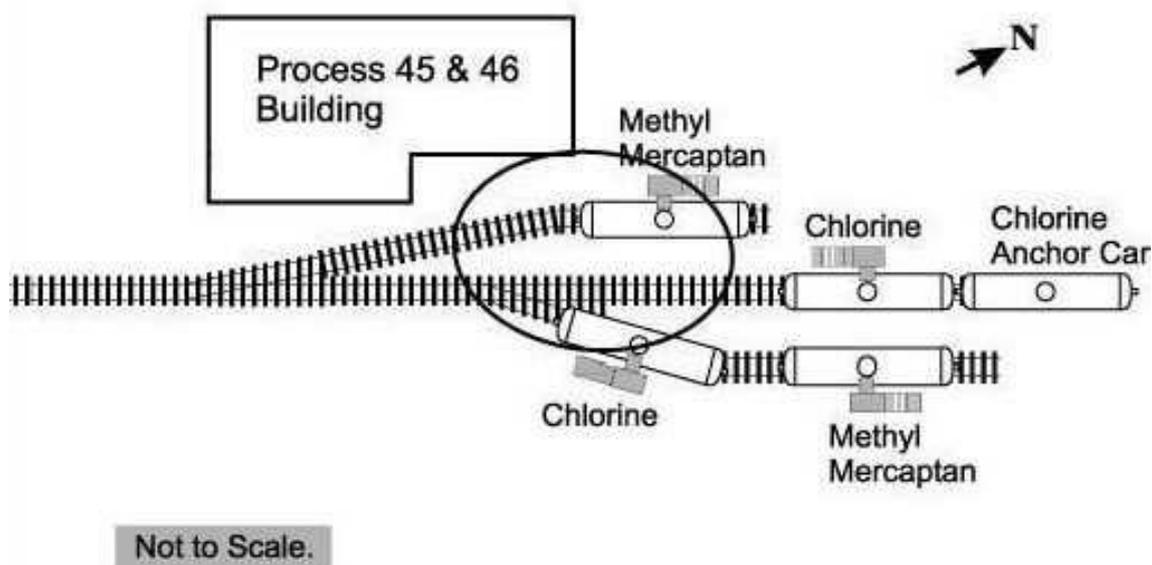
5. figure The location of railway wagons [11]

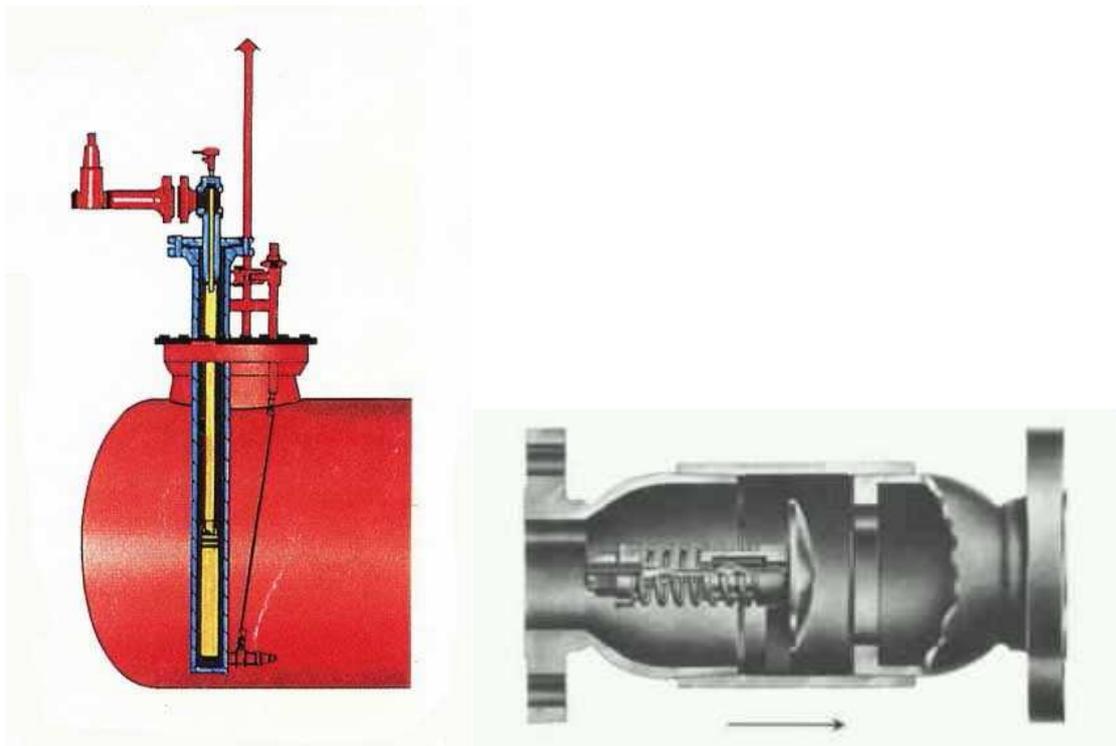
6. figure Safety valve [11]
